PipeLine Underground Trenchless Overhaul (PLUTO)

Project Vision

Improve pipeline longevity and maintenance efficiency by developing a minimally invasive, long-range, structural pipeline rehabilitation system

Project Objectives & The Concept

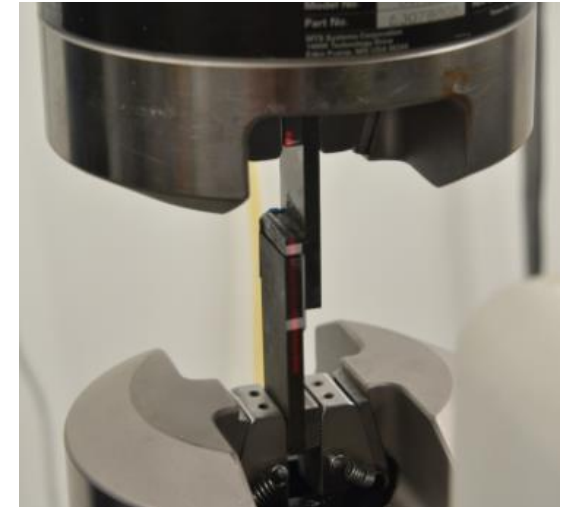
- Warren 501-02 epoxy initial material properties:

- ASTM D2990 10,000 hour creep test will begin in January
- Target liner thickness for testing purposes is 200 mils
- Lap Shear Testing:
 - Failures are adhesive (with mild cohesive behavior for ablated samples)
 - Target max load: 1000 lbf
 - Epoxy bonds more strongly and consistently to prepared surfaces

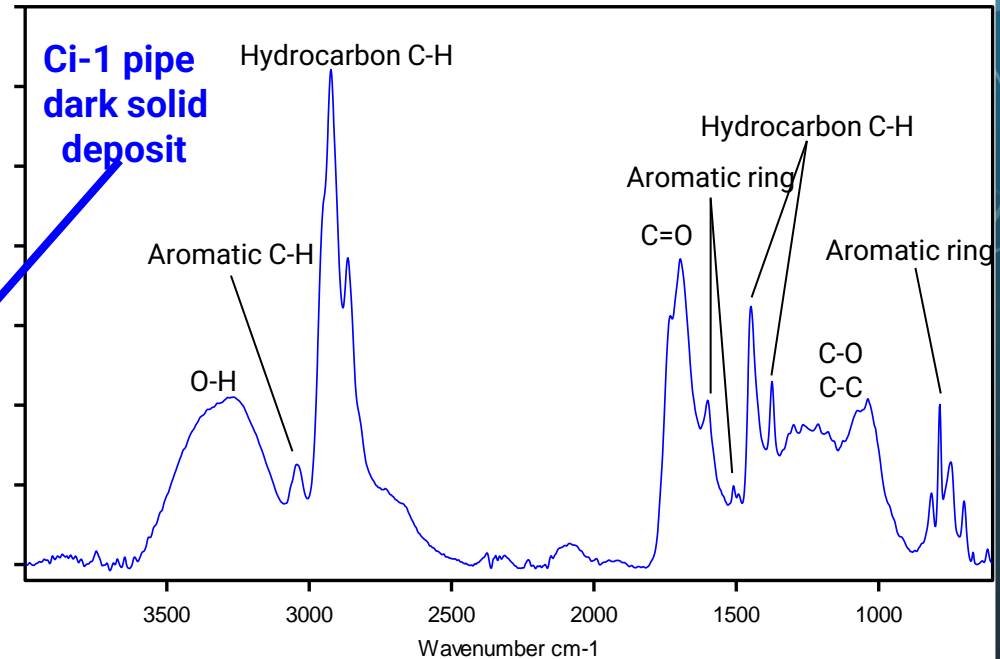
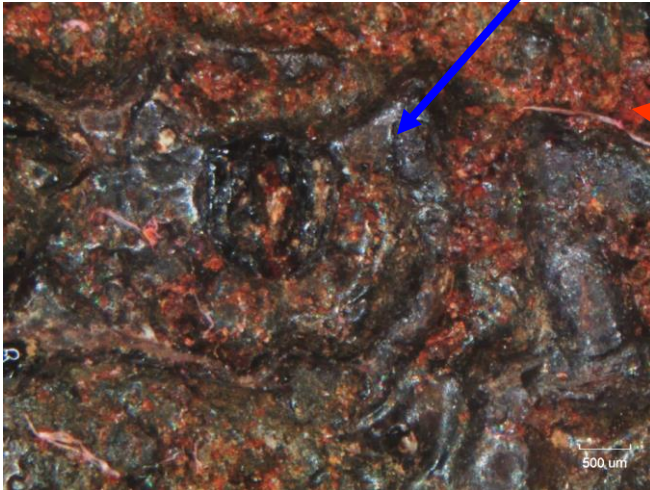
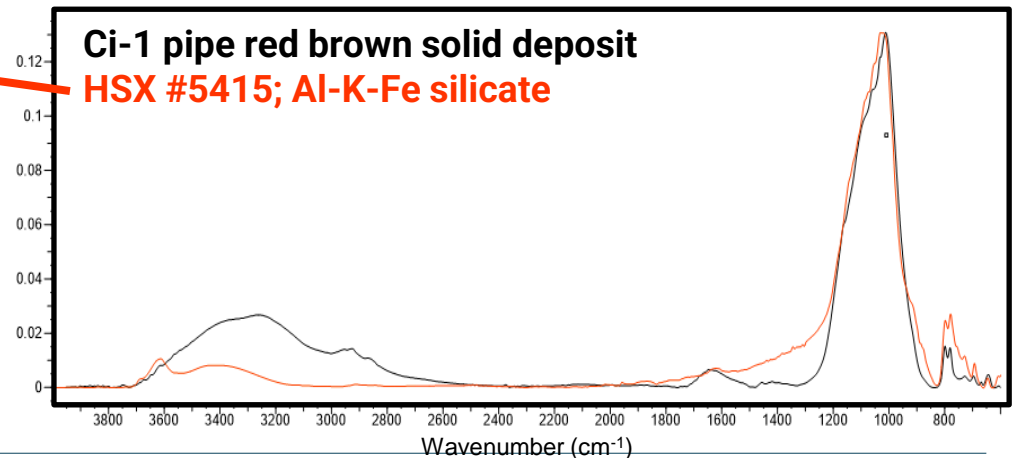
Results: Surface deposits on CI-1 pipe

The deposits on the surface of the CI-1 pipe are a mixture of degraded organics and an Al-Fe silicate.

The dark organic deposits have the IR features of hydrocarbons and aromatic rings. These organics can burn if heated in air due to the presence of C-H bonds.

The red brown solid material on the surface matches the IR features of an Al-Fe silicate well.

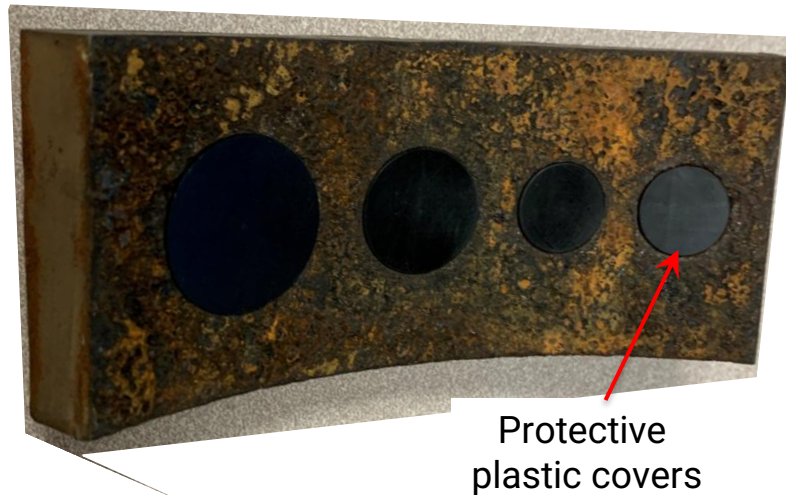
Results: Coupon Inspection Of Overcoated Defects

- 4 different diameter blind holes drilled in pipe coupon.
- Holes were “covered” with plastic plugs to keep them from being filled.
- Coupon coated at 200 mils.

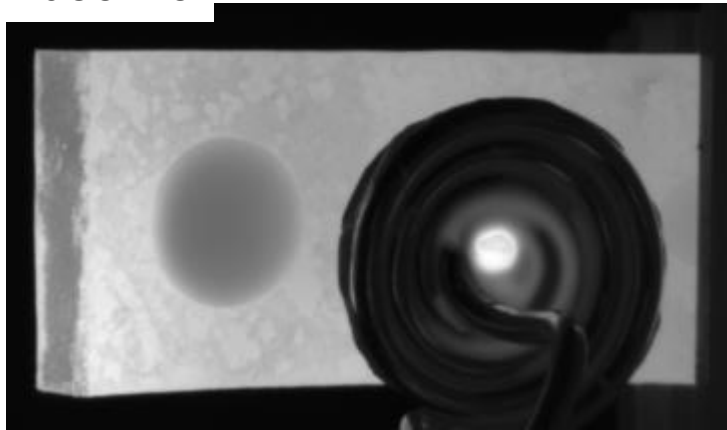
Baseline

IR image, large hole, uncoated part.

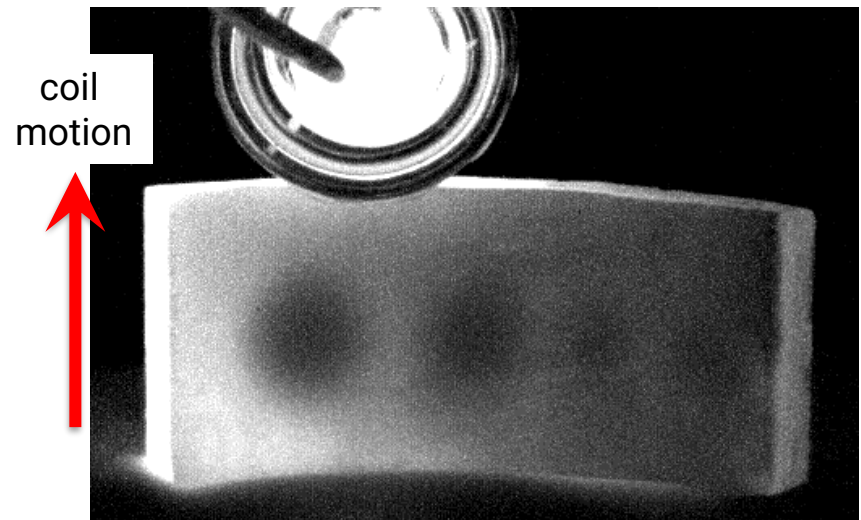
IR image, all holes, coated part.
